# HOT! HOT! HOT!

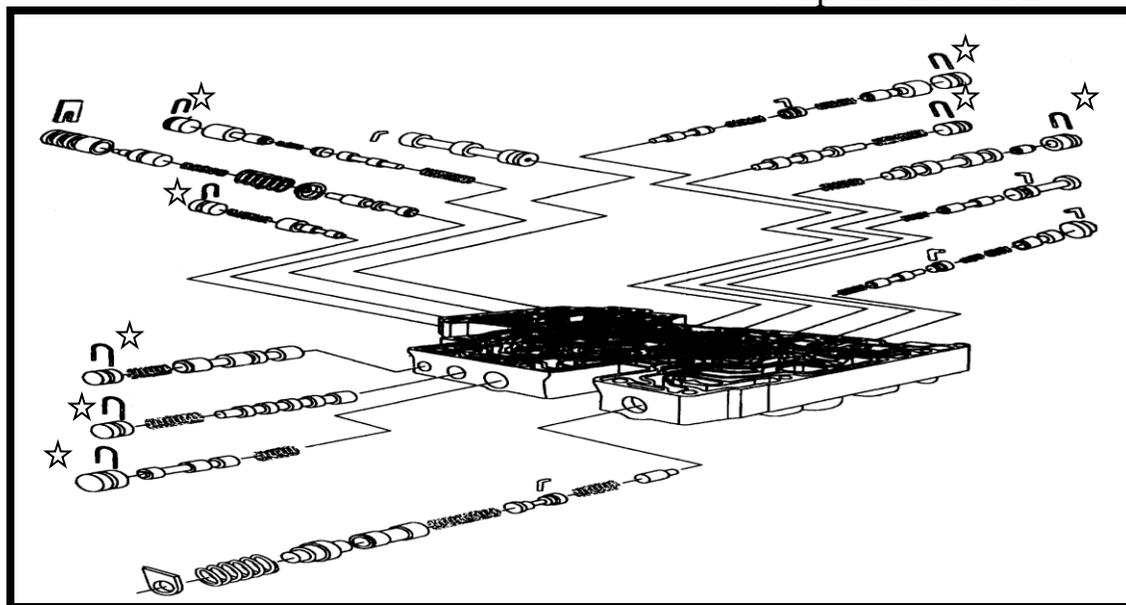
☆ Clip and Location

This is becoming one of the top ten tech calls regarding these transmissions. After overhaul, the vehicle has a good reverse apply one or two times and then loses reverse all together!!

The number one cause of this problem is the retainer clips that hold the end plugs in place have fallen out of place. There are a fine gauge material and will either fall out of the body entirely or "flip" into a different quadrant and hang up another valve train. Following is a diagram showing clip locations.
